Walnut Hill Club at Chilesburg Stormwater Improvements Lexington, KY March - May 2022

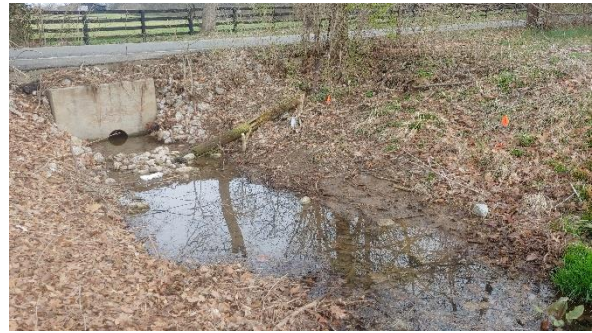
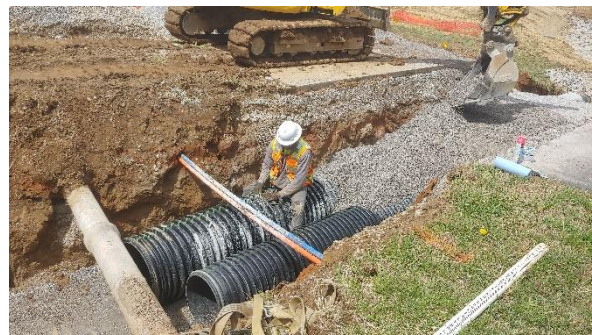
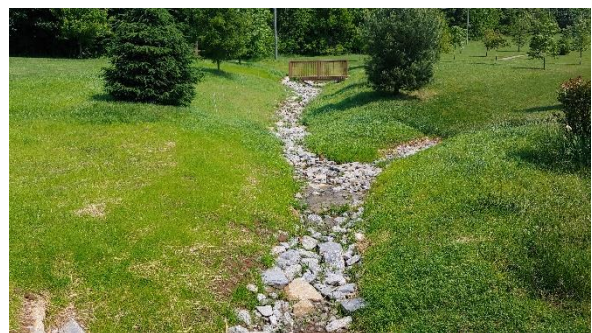
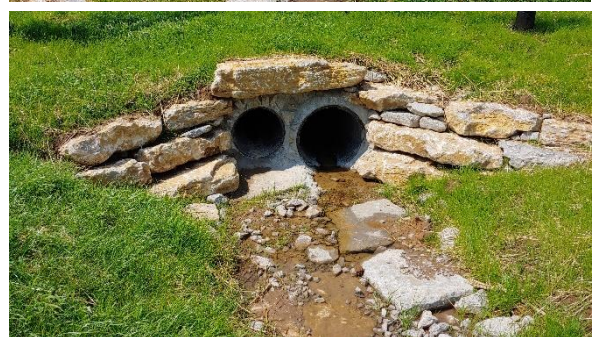
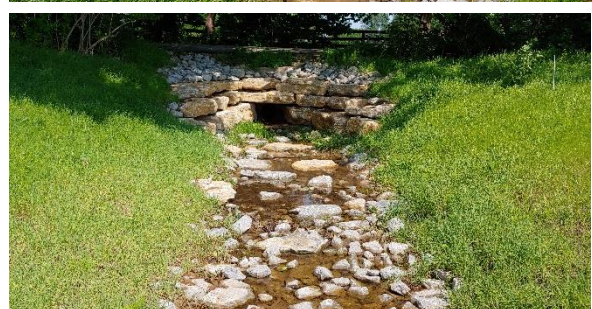
Three headwalls were created by stacking large native limestone boulders, offering a more natural look and consistent theme of materials. Over 400 linear feet of channel was armored with native limestone rock to halt erosion. In addition, the increased hyporheic area is now providing more treatment of the stormwater quality. A buffer of native grasses and wildflowers were planted along the upper 175 linear feet of channel to beautify the area, provide more habitat and further protect water quality.

The Owners Association applied for a Lexington Stormwater Quality Incentive Grant to help pay for the design and construction of the necessary stormwater improvements. A new, larger 30" HDPE pipe was designed as a replacement. However, during excavation we found numerous utility lines both on top and below the existing pipe. The proposed pipe wouldn't fit. Working as a team with Bell Engineering, we were able to quickly adjust and install both a 24" and 18" HDPE pipe, threading two pipes through numerous utilities.
